Re: Fire resistance test TE 94134

I am writing to briefly report the results of a fire resistance test carried out in accordance with European Standard BS EN 1366-2:1999 on an ActionAir multi-blade fire damper, nominally 1000mm x 1000mm, model Smoke/Shield PTC 501 + 1/F, on 21 March 2000.

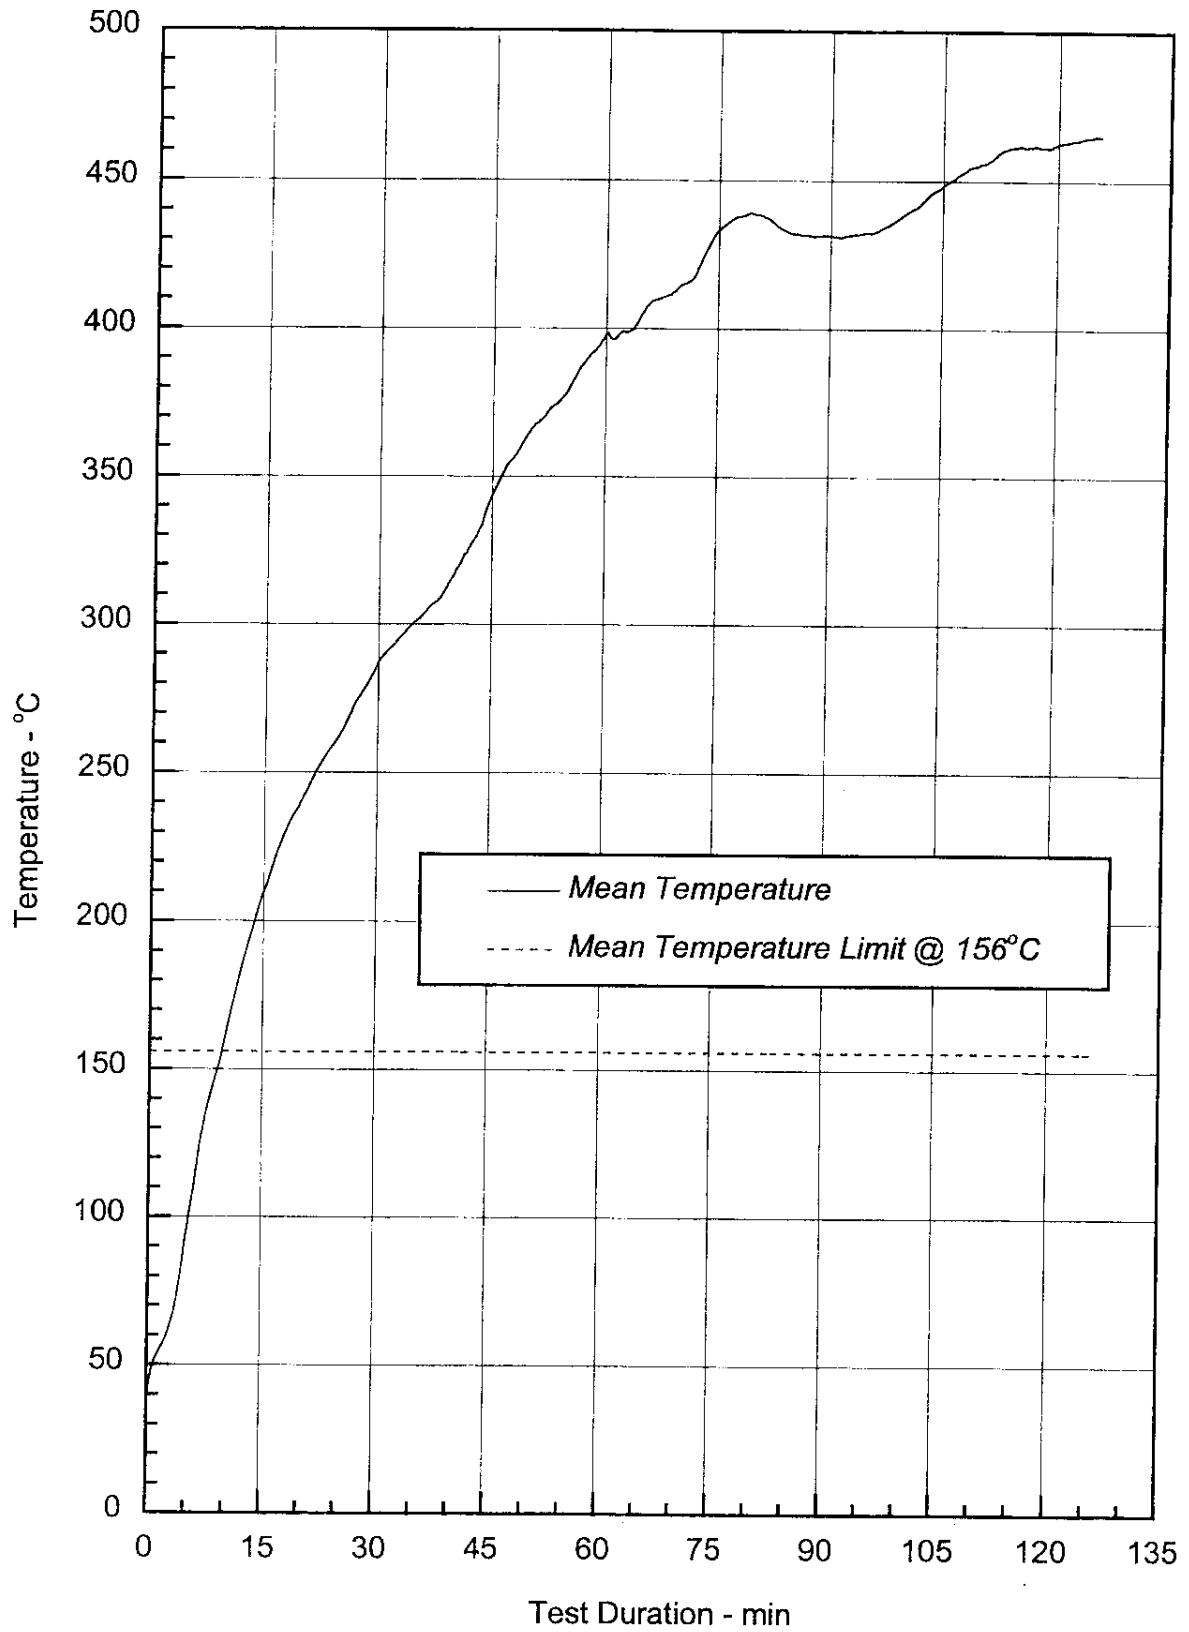
Figure 1 Mean face temperature recorded by thermocouples nos. 87-90

The mean and maximum temperature data of the specimen is shown in Figures 1 and 2. The airflow leakage through the damper is shown in Figure 3.

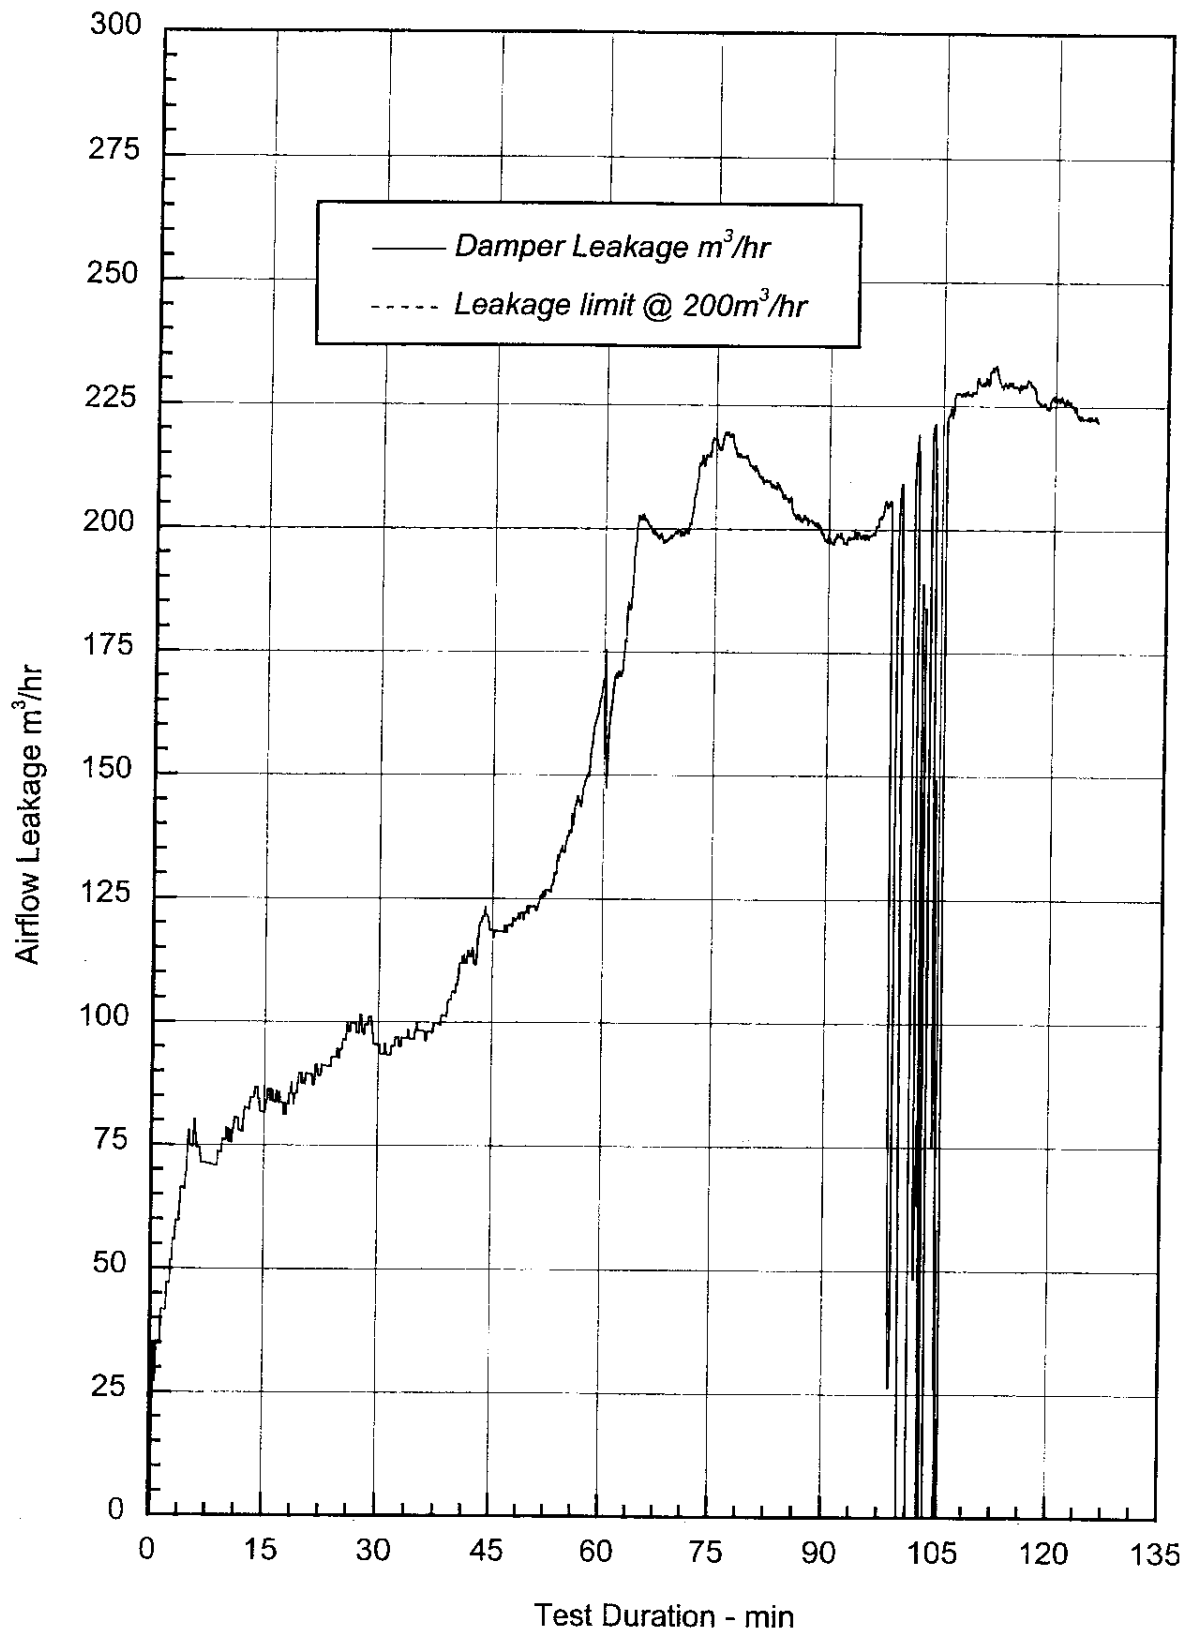
Figure 3 Airflow leakage through damper

The leakage of the damper at ambient temperature prior to the test was calculated to be 32.0m³/hr.

64:30	Leakage failure - 201m ³ /hr leakage recorded through damper. Small gap visible between top row of blades and spigot casing.
74:00	Galvanised coating yellowing to top of damper and spigot.
